## **Section 4**

# **Gearbox**

# **Rear Fork and**

*Velocette*

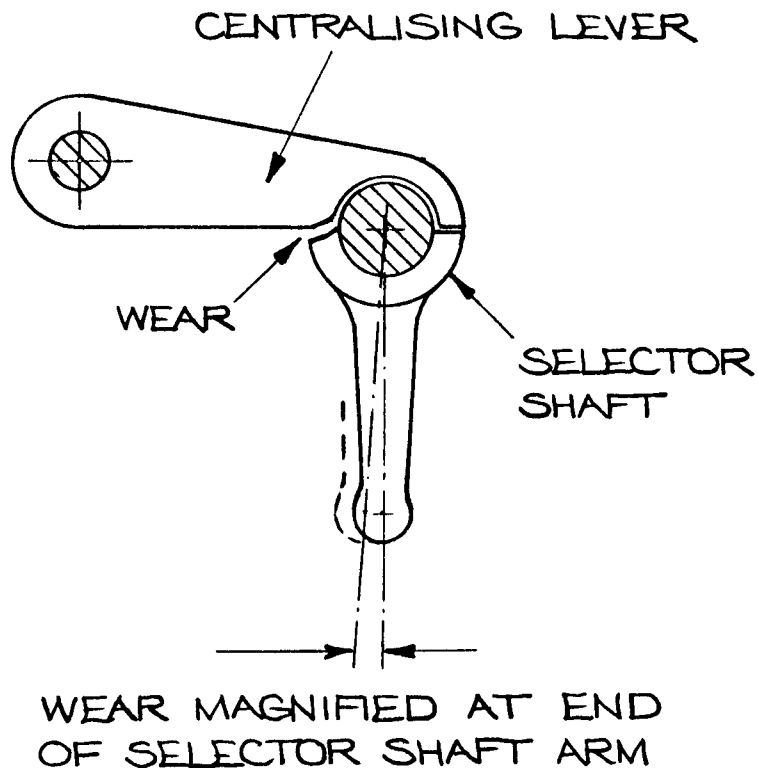
"The reason for this situation was not immediately apparent, but it was noticeable that if slight assistance was given to the selector shaft using a screwdriver to centralise it, the gearchange was successful. The selector shaft and centralising lever were then removed for closer examination.

The sketch indicates the areas on the selector shaft and centralising lever. Both parts had worn unevenly, and this had affected the centralising ability of the selector shaft in one direction of movement, i.e. downward gear changes. The total wear on both lever and shaft was probably in the region of 0.020in but, because of the greater radius of the operating ball from the selector shaft spindle the lost motion at that point was around 0.065in.

"Realising that new parts are not readily available, I was faced with with the problem of repairing the old ones. In my case, the offending parts were taken to a local welder where they were built up with 'stellite'. This was then hand ground back to shape using templates that had been made before welding. There is usually enough unworn profile to copy onto a thin metal template, to enable you to get the right shape.

Anyone not familiar with 'stellite' might be interested to know that it is a very tough metal and is commonly used where a wear resistant surface is required. Once the mechanism was re-assembled using the repaired parts, a full and positive set of gear selections was achieved.

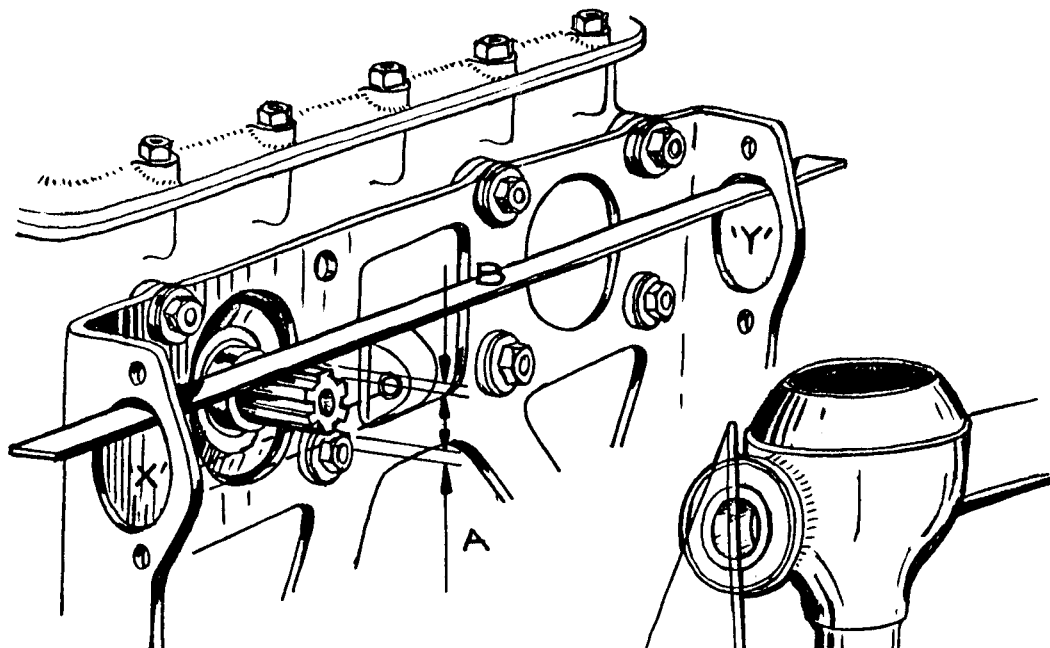
"Returning to my problem. Having eliminated the clutch and, as a last resort, I turned to the muff coupling. Pulling the prop shaft out - that certainly was now loose - I found that all that remained of the splines inside the coupling were a few bits of 'wire' and a large amount of sticky dust!

"Analysing this discovery, there seemed two possibilities. Firstly, that there was some gross misalignment between the propshaft and gearbox shaft (any misalignment would be taken up by the propshaft bending as the bevel box casing flange nuts were tightened down). Secondly, that the muff coupling had been made of some inferior material - the genuine article being made of something around 65 ton strength material ('T' condition).

"What was very noticeable here, and which I especially want to draw your attention to, was how the error is dependent on the rubber gearbox mounts. To my amazement a large screwdriver placed under the gearbox was able to produce something like 1/8in. of movement between gearbox and the frame cross member. Now I must confess that I had never really considered the mounting rubber bushes to be any more than "bits of rubber", whereas I now see that their condition is absolutely fundamental to proper alignment. I cannot help wondering if neglect of this point is a major contributor to the high incidence of loose and failing muff couplings, since more often than not you find these rubbers are worn, split and softened by continual leakage of oil from the gearbox output shaft. The lesson to note from this is that these parts should be replaced routinely during any restoration or rebuild. The Club's Spares Scheme has the buffer and washer in stock. Valiant owners do not have this problem since the rear fork is rigidly fixed to the back of the gearbox.

"Turning to the question of muff coupling material, my metallurgy friends were soon able to establish a major deficiency here too - a material of only around 40 tons strength had been used. It might have been a one off, it might have been an inferior replica part, or it might have been a part that Veloce made.

"Alignment is not too difficult to check. If the centre line of the bevel box mounting flange is found (from the bolt holes) and the rear fork flange is stood vertically on a flat surface, the centre line of the rear fork pivot bearings should come vertically above the flange centre line. This can be checked with a large set square, as shown in the sketch. This check revealed something like 1/16in. misalignment. The other possible alignment error is between the gearbox output shaft and the centre line of the rear fork pivot holes. These are in the frame cross member, which is bolted to the back of the gearbox. This can be measured by placing a straight edge through the two holes and measuring the distance between the bottom of the shaft and the straight edge (A) and top side (B). Any misalignment here will be calculated as 'A' minus 'B' (again see sketch).
