# **Reducton Gear**

# **Starter and**

# **Clutch**

## REDUCTION GEAR, STARTER & CLUTCH

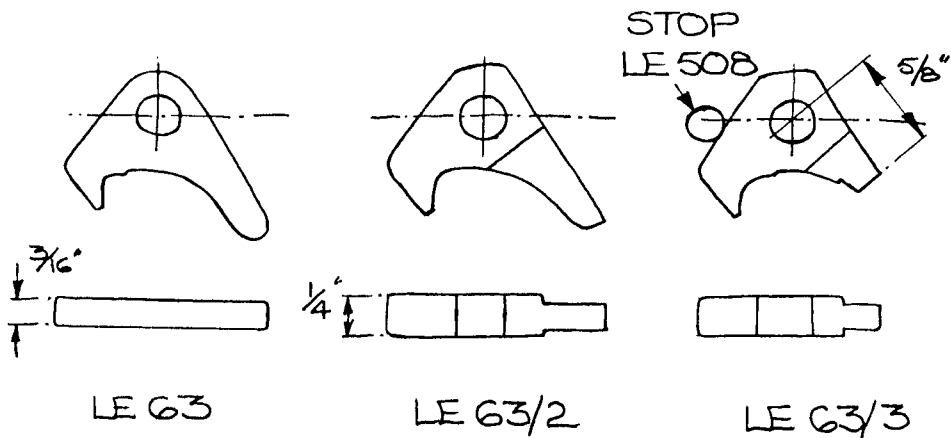
A word or two of caution. The drilled end in the rivet is very important and a proper, large size 90 degree punch must be used to splay it open. As you will be hammering against the riveted head of the pivot, it is vital to support the reduction gear squarely on the bench. Otherwise the pivot will bend and jam the pawl solid. A second word of warning. Any new pawls will undoubtedly be of the later Mk III LE63/3 type. These are not a suitable replacement for the earlier LE63 or LE63/2 design, unless a later type reduction gear with stops (LE803) is used. The later LE63/3 type dispense with the long "tail" which prevents centrifugal force sending the pawl flying outwards. The stop takes the place of the "tail".
